# Floating water quality islands in Hicklin Lake, White Center

Sally Bartley Abella

King County Water and Land Resources Division

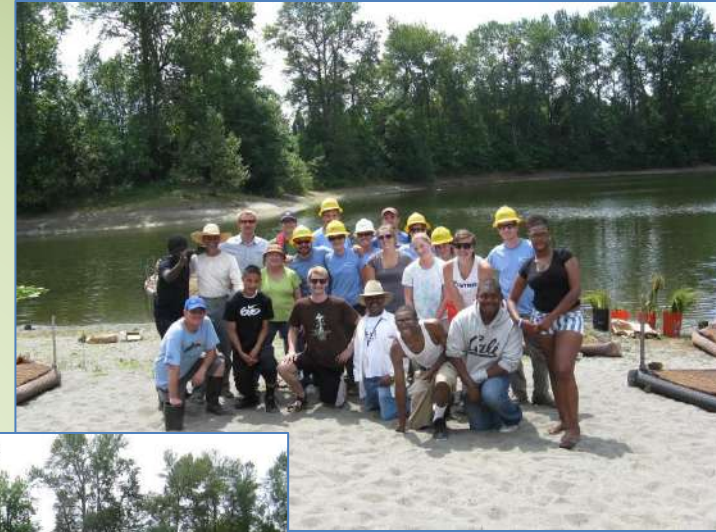
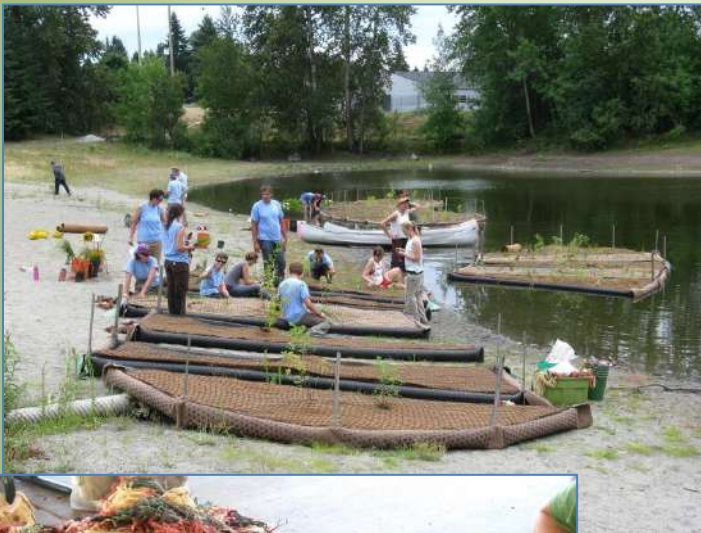
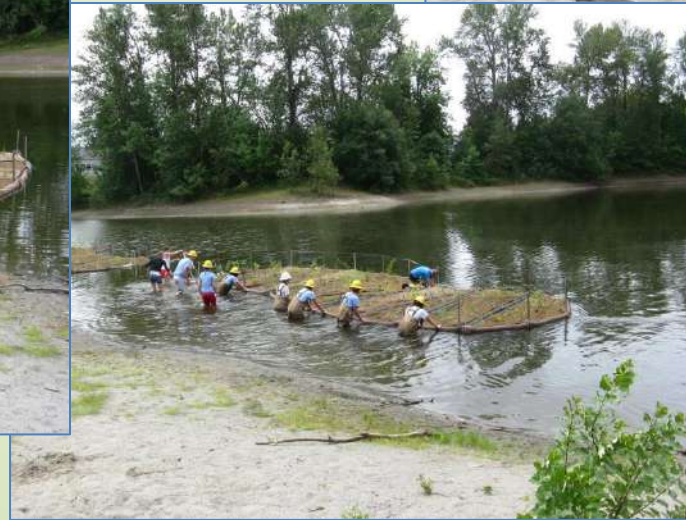
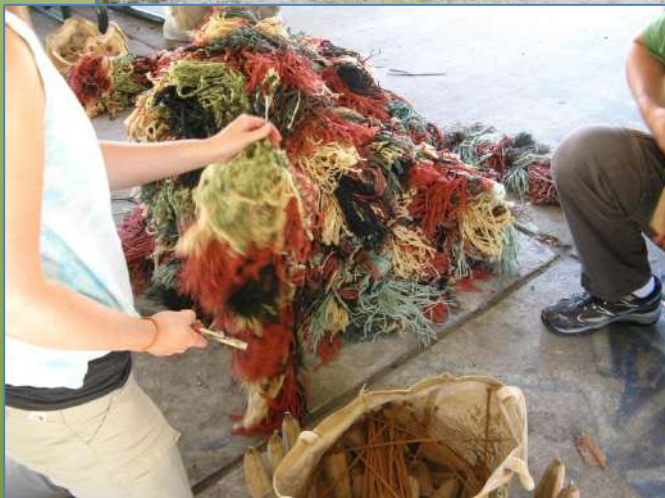
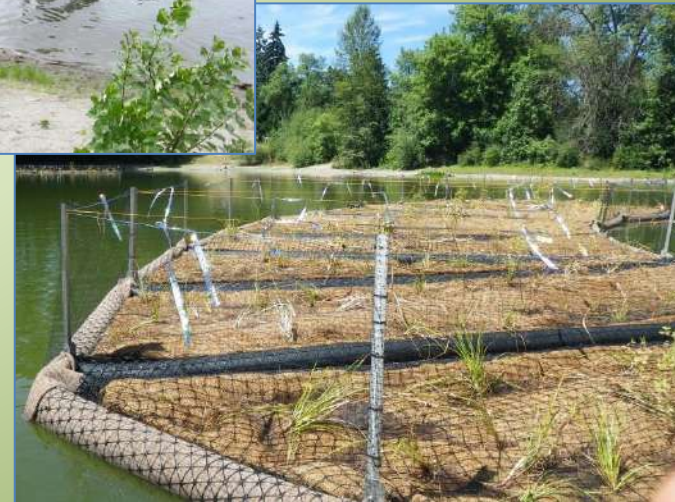
# Installation: a community event

- King County staff and contractors,
- Washington Conservation Corps team,
- KC Youth Source interns, and
- University of Washington students

The lake level was LOW! Note lack of emergent vegetation around shoreline.

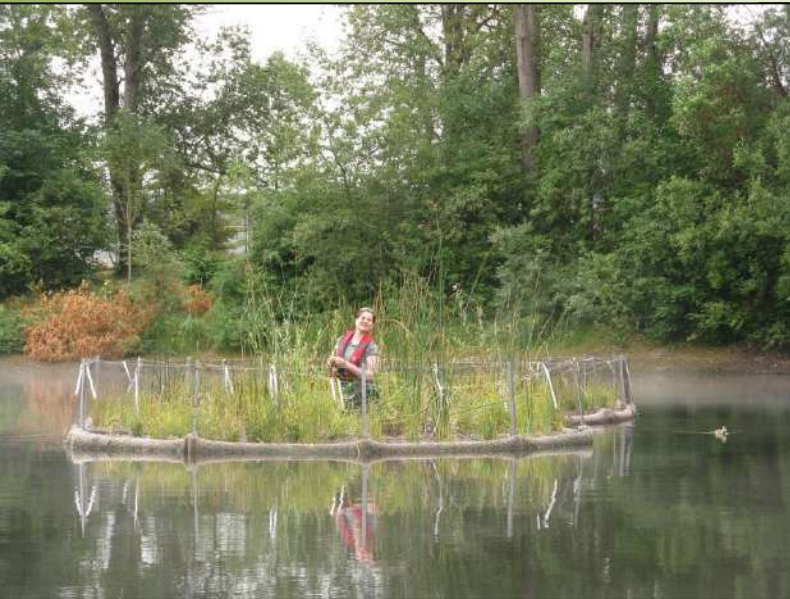
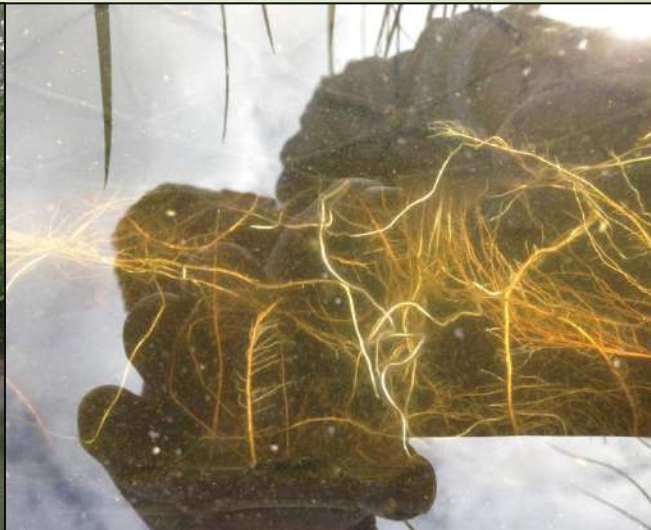
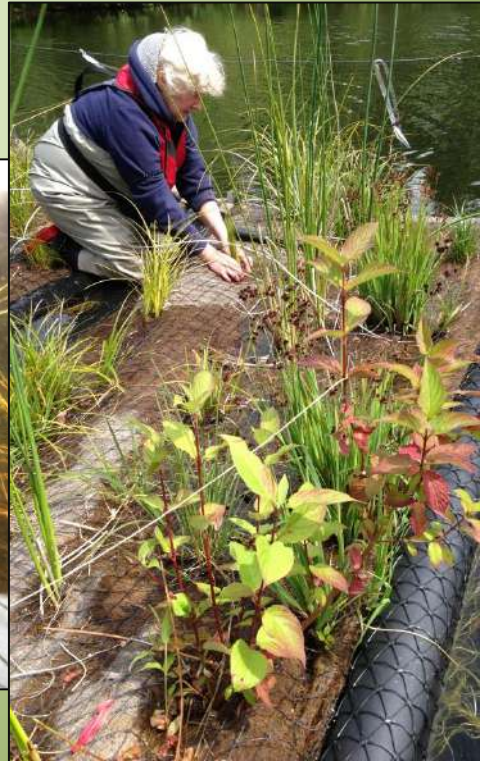
- Annual weeding in late spring sufficient; check-back in fall.
- Mortality less than 10%, mostly small sedges planted high.
- The shrubs will need to be pruned regularly.
- Blown-in weeds can establish quickly.
- As the plants grow, it's harder to maintain the plants ...need chest waders to get on the islands.
- Ducks stopped by fencing, but do rest on the edges.
- Kids throw rocks! Center placement helps.

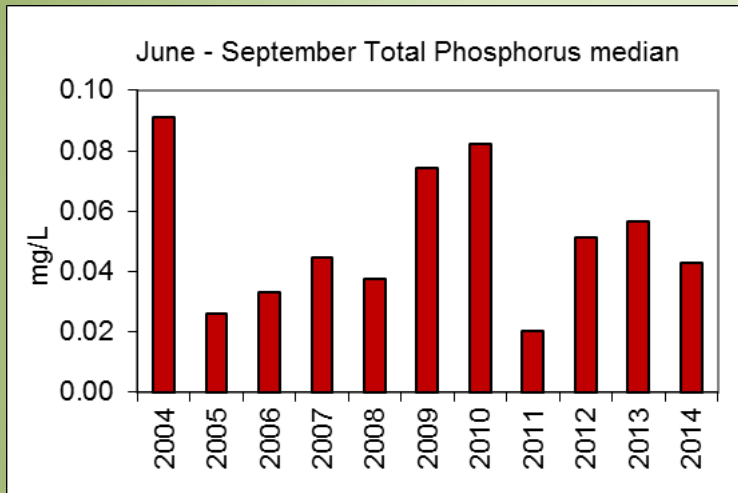
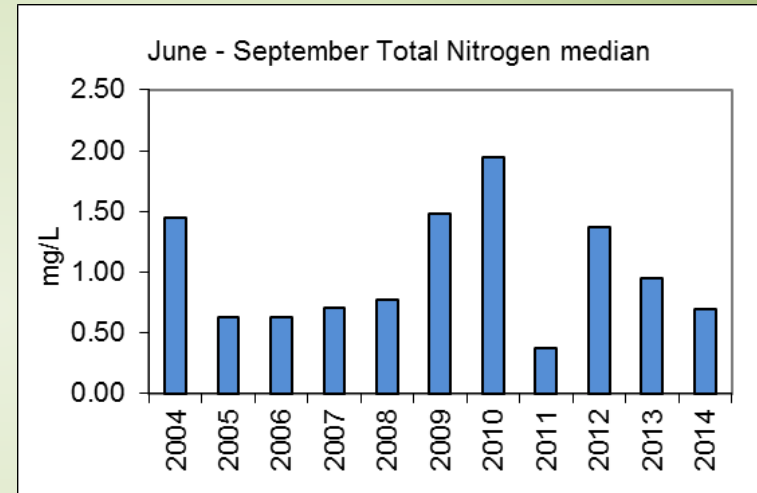
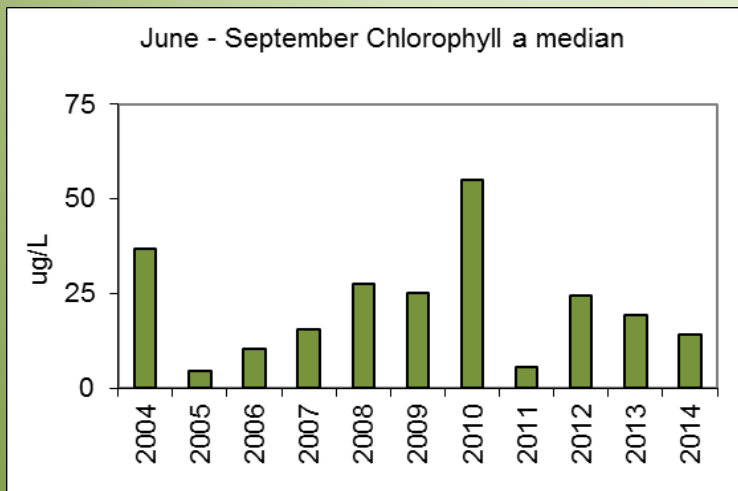
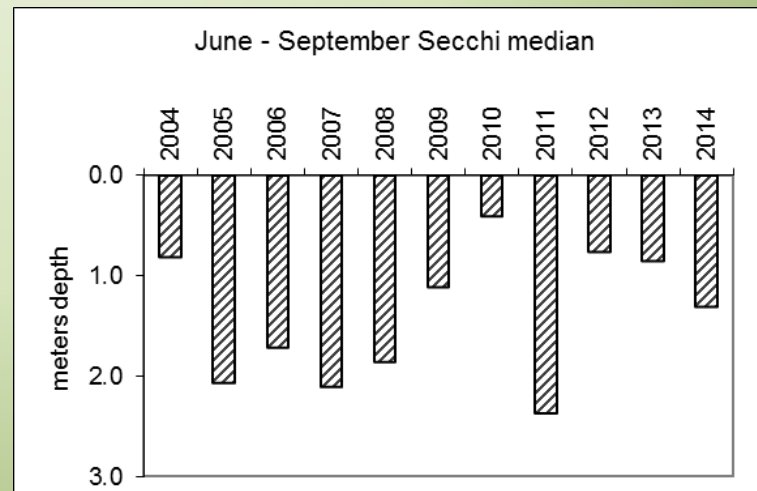
# Water quality monitoring:

Important dates: April 2005 first alum;  
May 2011 second alum;  
July 2013 floating islands

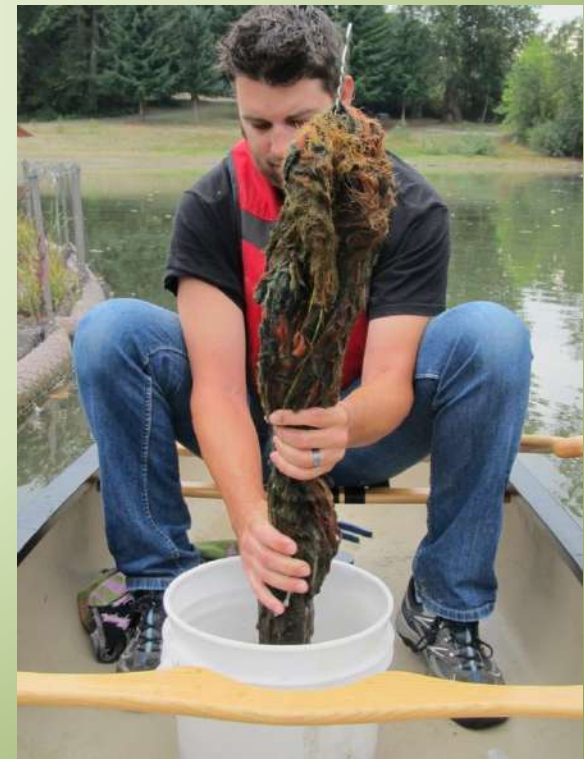
# Dynamic media columns:

- Inert material to create underwater surface area like root systems.
- Can remove and squeeze material off to measure N and P content.
- One column from each island, June and September in 2014.
- Measurements from one column in Fall 2013 produced similar values.
- NOTE: Observation of large root systems at the edges suggest that more biofilm may be on living roots than on the columns.

Total mg / media column	
		Total N	Total P
East island	6/10/2014	11.85	1.67
	9/16/2014	66.56	10.24
	<b>Increase %</b>	<b>562</b>	<b>613</b>
West island	6/10/2014	9.94	1.37
	9/16/2014	54.75	8.71
	<b>Increase %</b>	<b>551</b>	<b>635</b>
